Forest Aquatic Restoration Project NEPA Compliance and Implementation Checklist

Date: March 21, 2016

Title & Category: Headwaters Spring Protection / Category 9

Site visits to 8 Spring Sites on May 11, 2015 by Gale Shepard, Jaime McCormick, Hazel Owens, and Bill Wall for the consideration of protecting and restoring these springs.

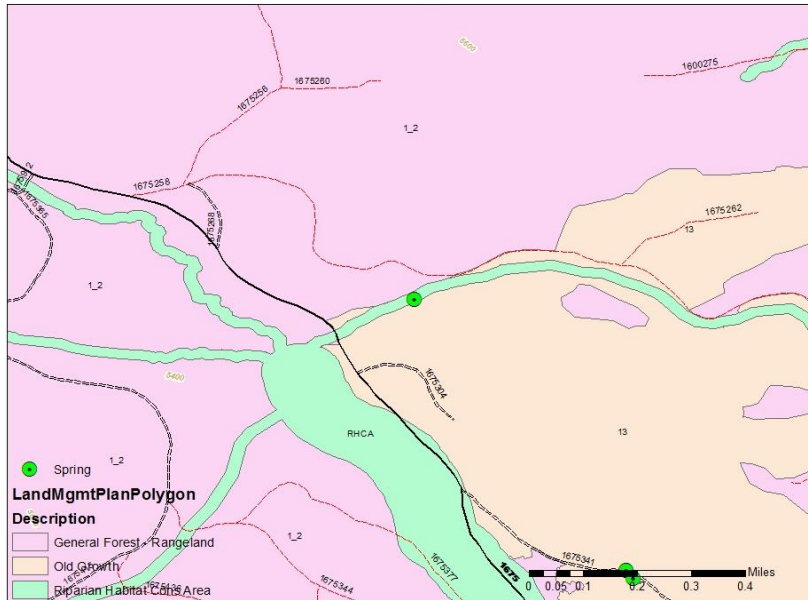
BC 3 Springs (1:10,000)

Very low flow. Spring temperature @ 1340 was 43°F. May need to perk the springs to get adequate flow to trough. Head box would be placed at downstream end of pond. Pond is heavily silted in with very low diversity of riparian vegetation, likely due to hoof action and grazing impacts. Pond would be fenced to allow for veg recovery. Perking the springs may reduce recovery, but there would not likely be a loss of present diversity of vegetation. May not be sufficient surface flow for spring and trough to maintain present saturated soils without a float valve at the trough. Trough would be place as close to head box as possible, though presently proposed at approximately 40 ft. Due to low flow drainage would likely go dry for these 40 feet. What riparian vegetation is present is not continuous downstream. Flow from pond appeared to be less than 300 ft. Drainage has minimal riparian veg between the pond and Bear Creek. Trough would be very close to drainage so ground around the trough may have to be hardened. Since the near surface ground water and riparian vegetation can be maintained, this project would fit category 9 of the Aquatic restoration EA. This is assuming there are no negative effects to TES botanical species.

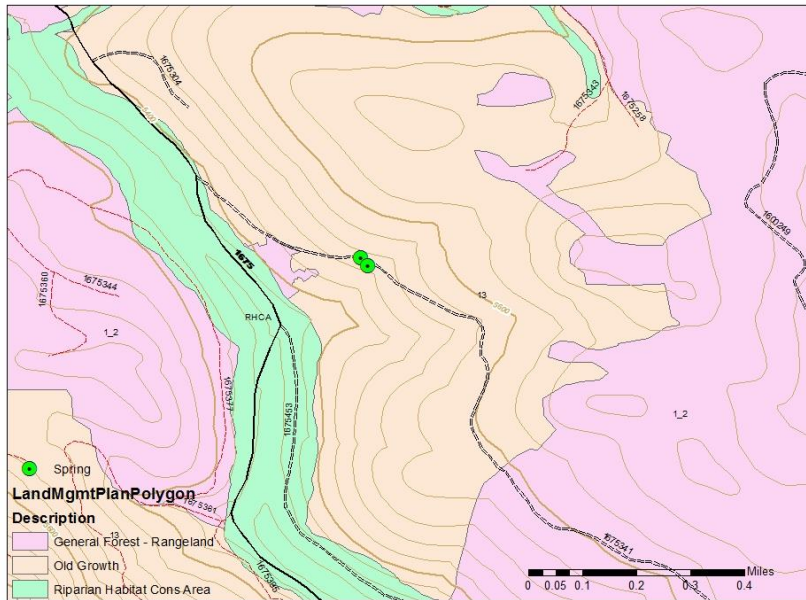
BC 1 and 2 Springs (1:10,000)

Very low flow in BC 1 and moderately low flow in BC 2. Spring temperature @ 11420 was 50°F at BC 2. Springs are closely associated with the road prism. Proposal is to put a head box and trough for BC 2, but just protect the spring and riparian area at BC 1. Both springs are likely connected. Distance from proposed head box to trough is approximately 25 ft. Effect of surface saturation would likely be within this distance. Likely to be adequate near surface ground water to not measurably affect riparian vegetation. Would not need to perk springs to get adequate flow to trough. Hoof action and grazing impacts are visible. This project would fit category 9 of the Aquatic restoration EA. This is assuming there are no negative effects to TES botanical species.
